Annual Review & Annual Rehabilitation Report

1 JULY 2020 – 30 JUNE 2021

Australian Strategic Materials Ltd Dubbo Project

Biodiversity Offset Area - analogue vegetation plot monitoring
Dubbo Regional LGA NSW
Spring 2020

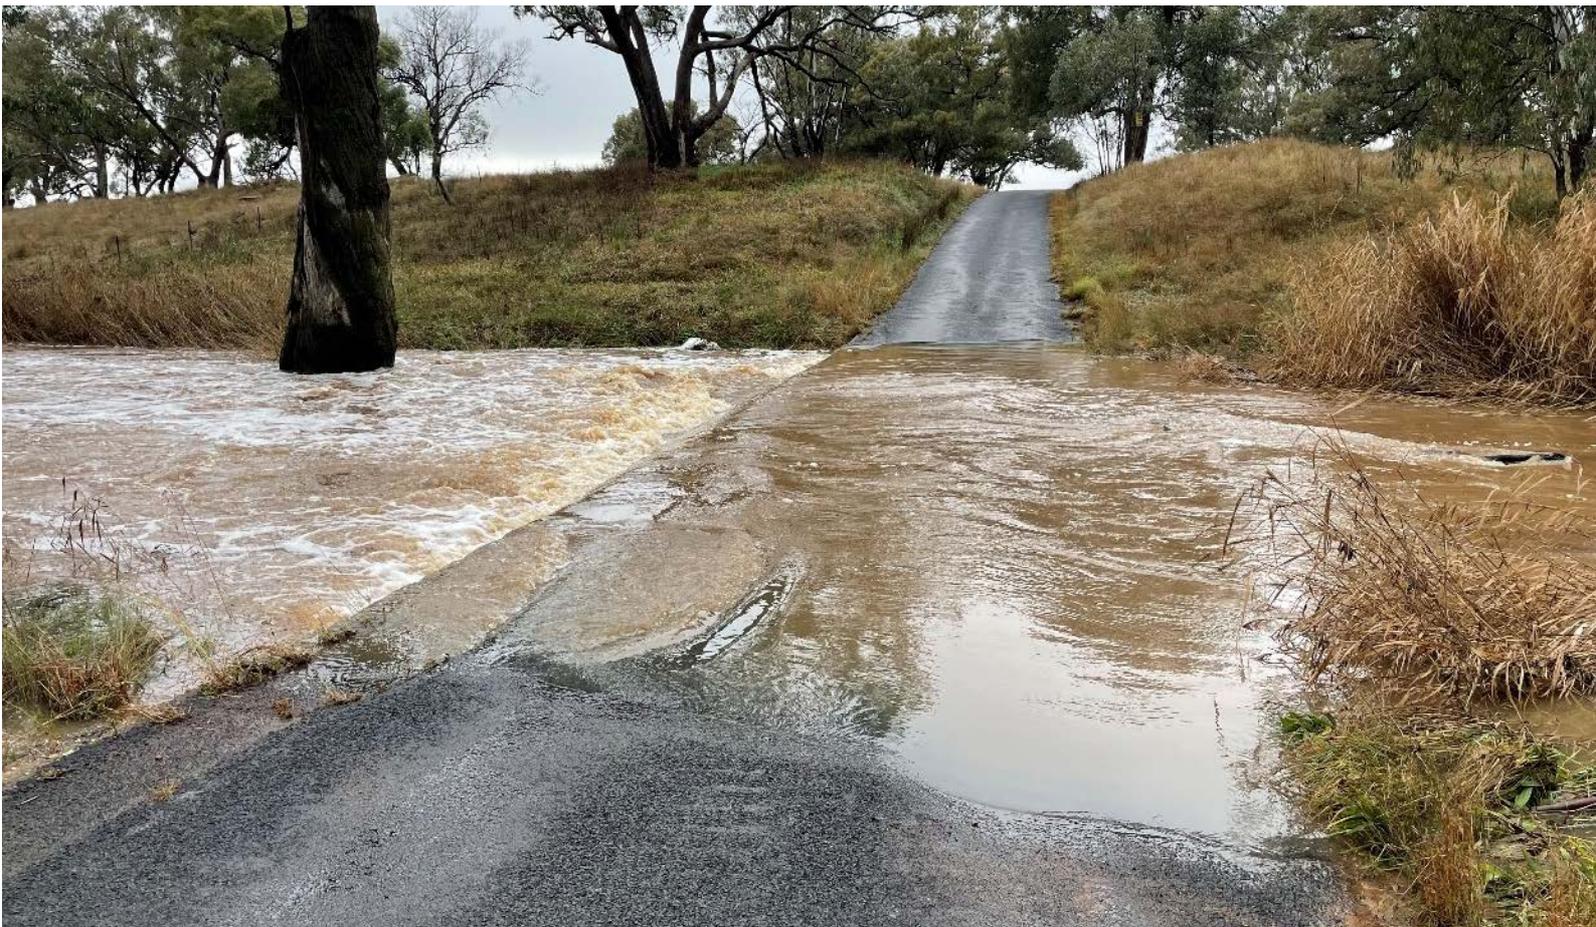
Toongi Road, Wambangalang Creek causeway. Photo taken 2 July 2021.

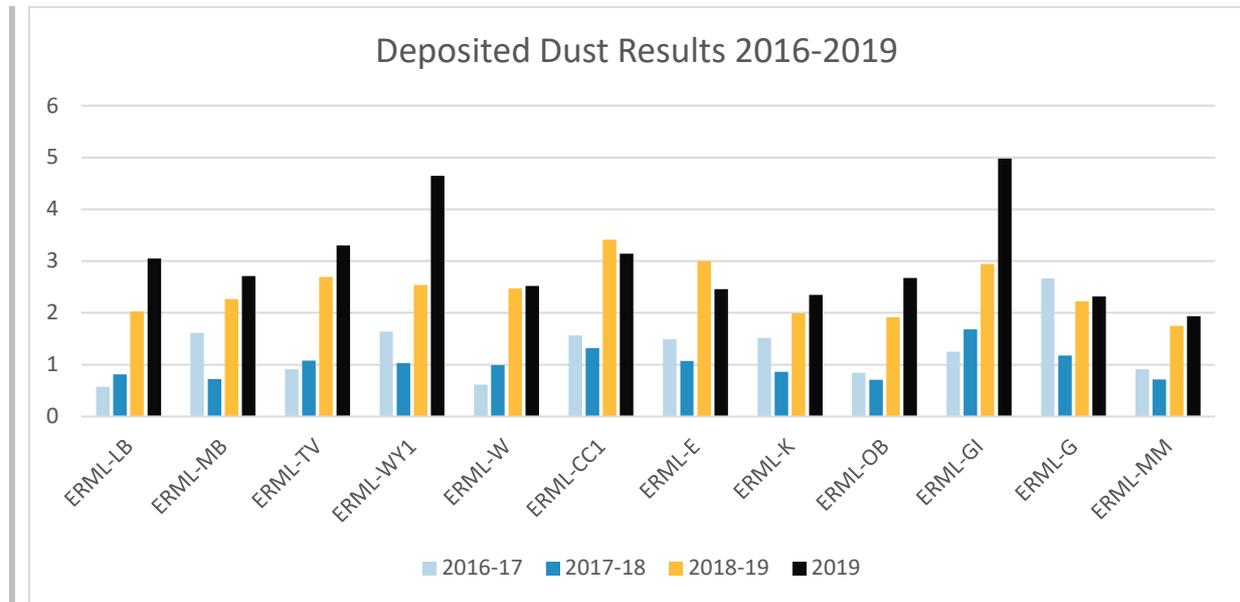
Figure 5: Deposited dust results for 2016-2019

No dust management measures were employed during this reporting period as project construction has not commenced. These are baseline monitoring results influenced by seasonal and routine agricultural practices.

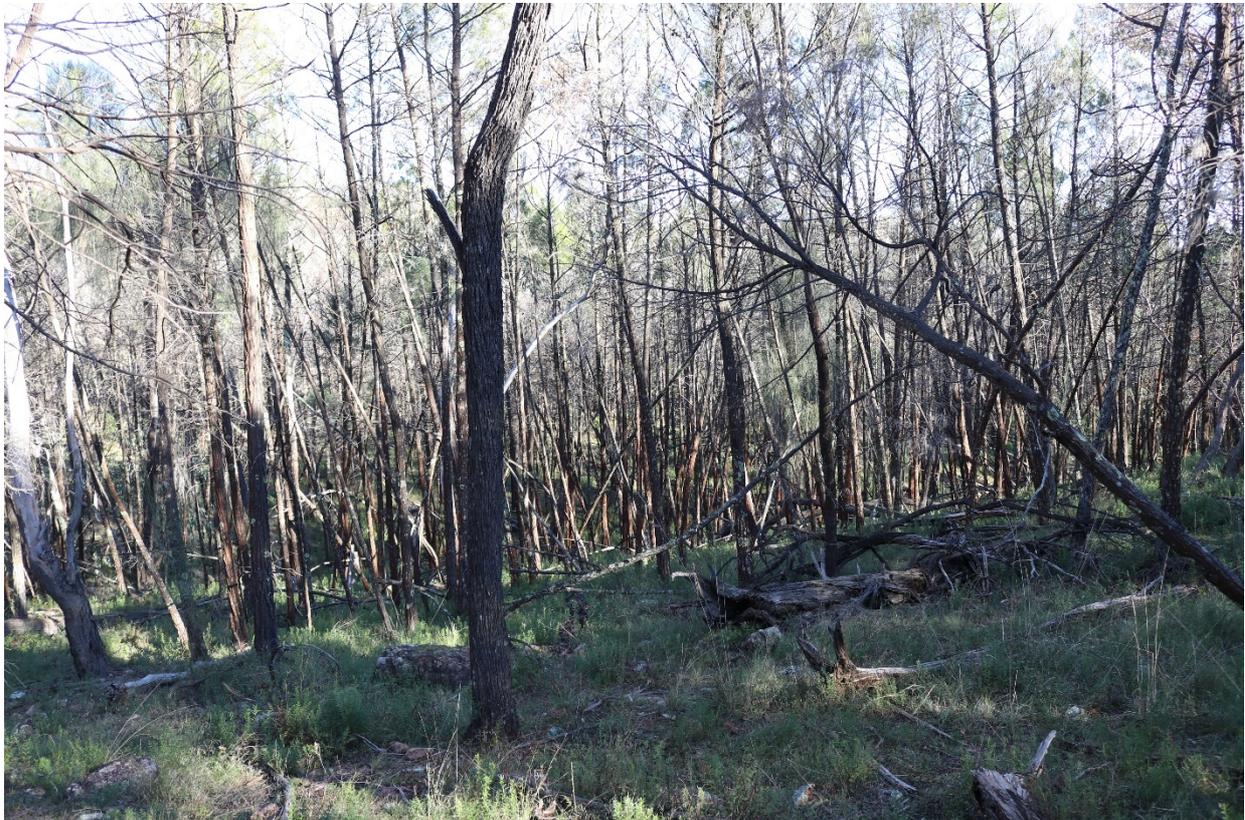
It should be noted that there has been significant dieback of trees across the whole project site from 2017 to January 2020. Black and White Cypress pine, Drooping She-oak and even red stringybark have died due to prolonged dry. With that dieback more sunlight is reaching the ground which has enabled growth of grasses and forbs as they have not done in decades. Thick stands of pine trees have groundcover up to 100cm high where in a normal season there would be very low and sparse cover. The photos below illustrate this fact.

*Die back of Black and White Cypress Pine (*Callitris endlicheri* and *C. glaucophylla*) on Dowds Hill during 2018-2019 drought has created an opportunity for succession plant communities. Photo taken on Dowds Hill BOA 27 June 2021.*

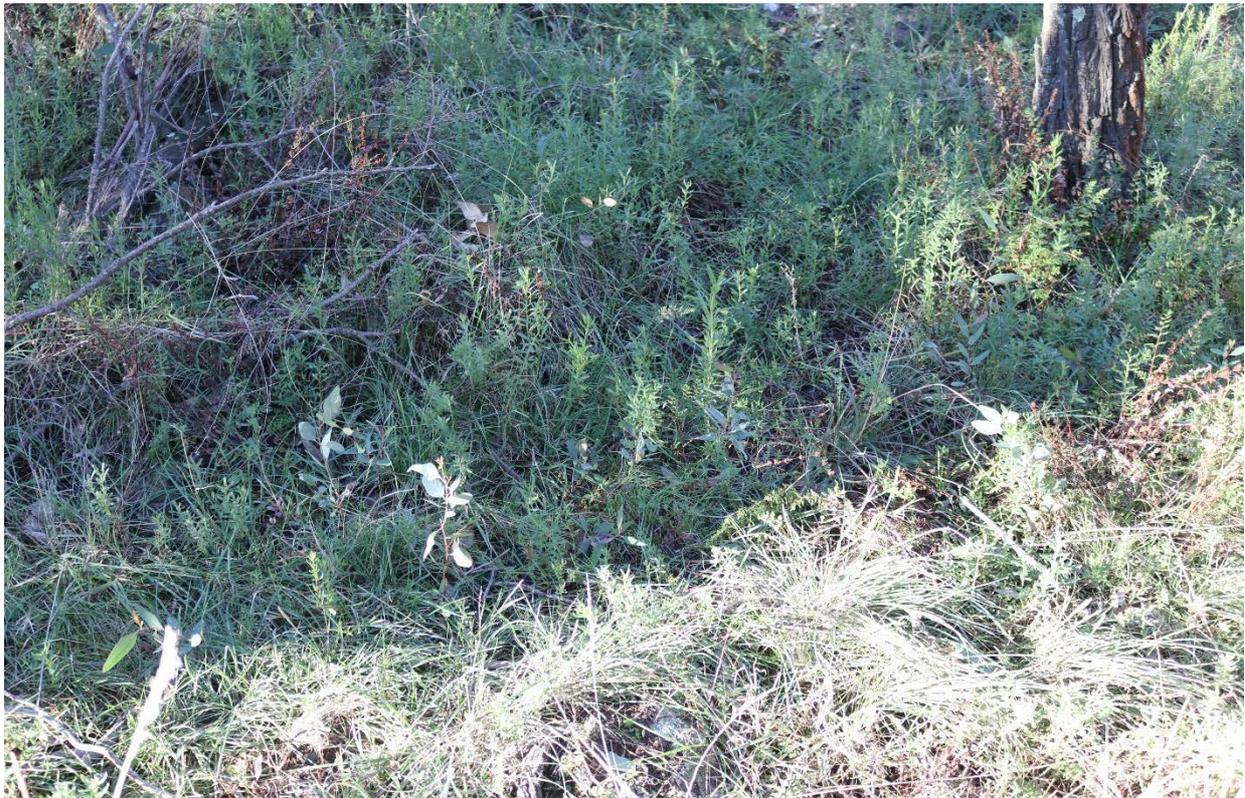
Eucalypt seedlings regenerating on Dowds Hill. Currawang (Acacia doratoxylon), Drooping She-Oak (Allocasuarina verticillata), White Cypress Pine (Callitris glaucophylla) and Tumbledown Gum (Eucalyptus dealbata) are all regenerating in space created by dieback and good seasonal conditions. Photo taken 27 June 2021.

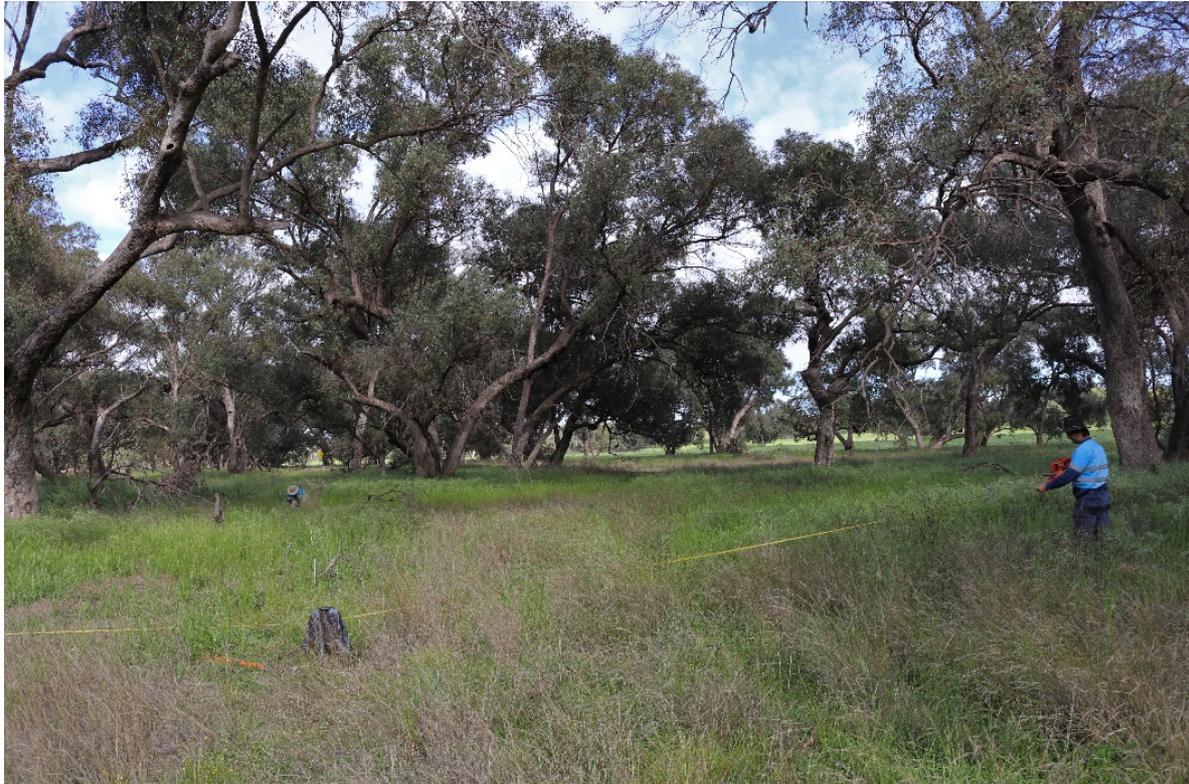
Vegetation plot survey near Toongi Hall in a Fuzzy Box (*Eucalyptus conica*) Woodland on 25 September 2020.

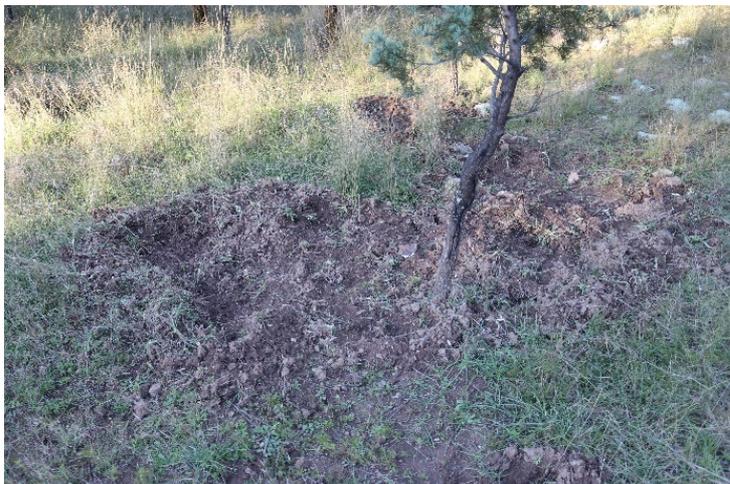
Pig diggings close to the orebody. Photo taken 27 June 2021.

Kangaroos, feral pigs, foxes and cats have been the focus of pest control programs during this period.

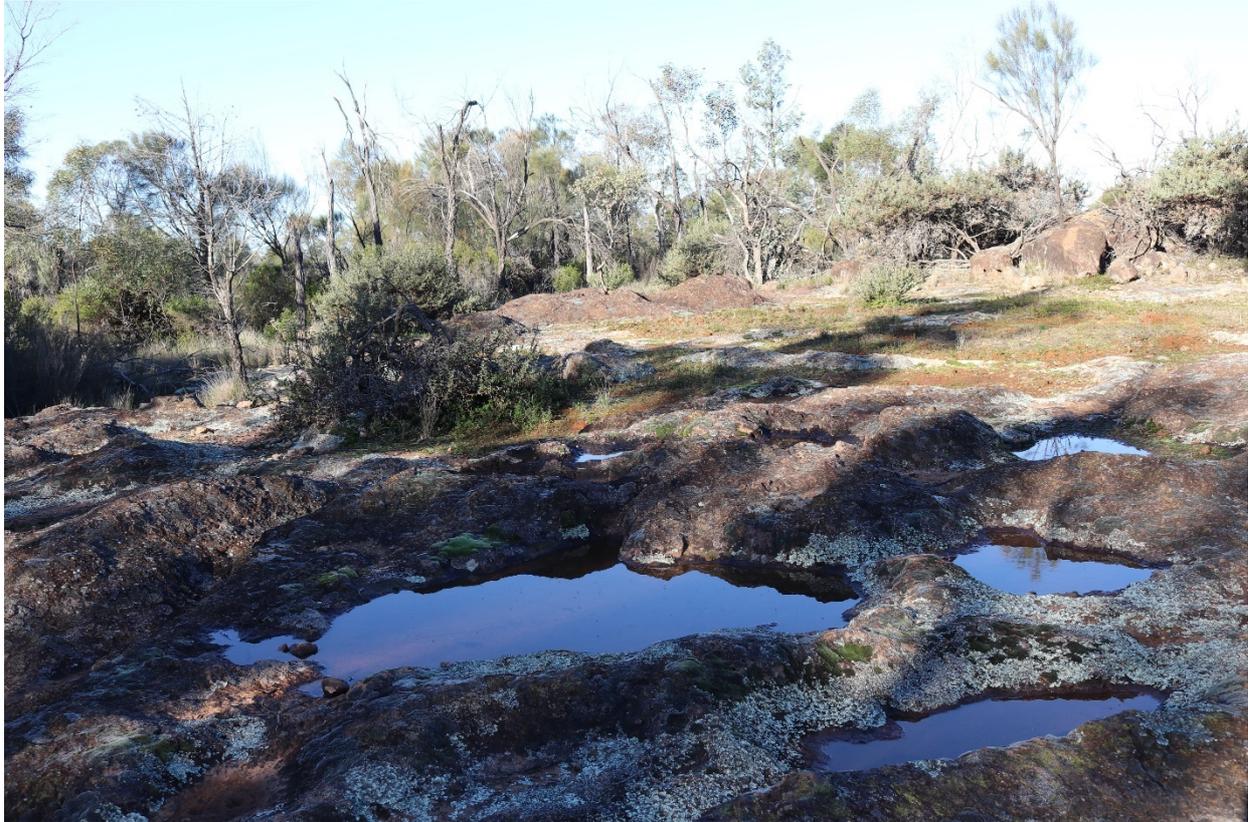
Rainfall held in rock pools on the summit of Dowd's Hill enable feral pigs to water and feed close to cover and away from crops and pastures where they are more easily controlled. Photo taken 27 June 2021.

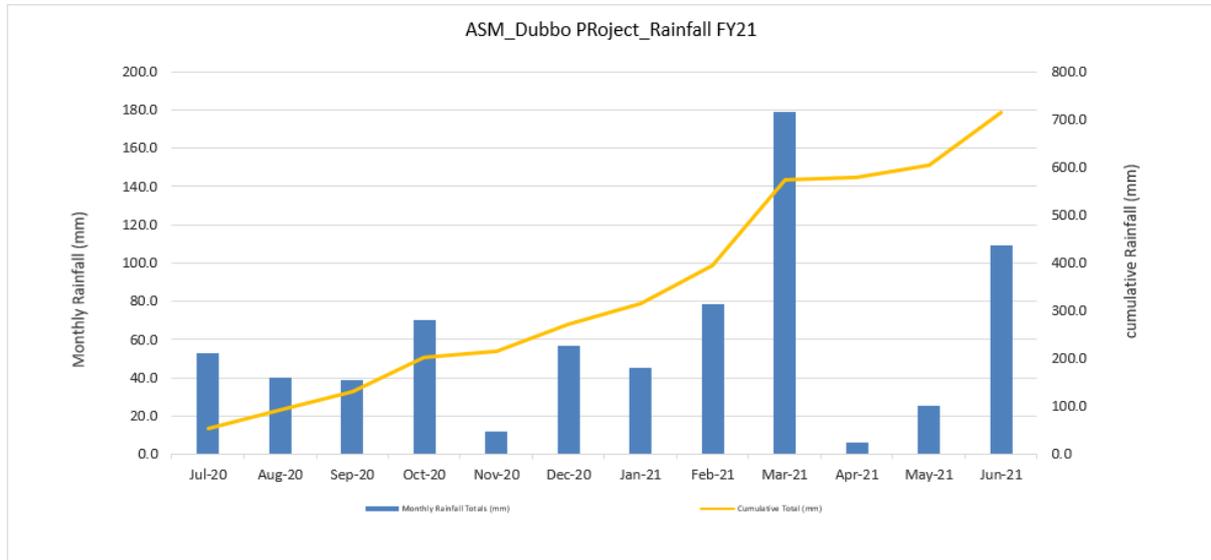
Figure 6: Monthly and cumulative rainfall on project site to 30 June 2021.

A total 714.6mm of rain fell over 84 days in the reporting period which has broken the drought of well below average rainfall years in 2018-2019. A below average total of 458.9 mm rain fell in the preceeding twelve months. The drought started to break in January 2020 and despite a relatively dry April-May 2021 the growing season has been phenomenal.

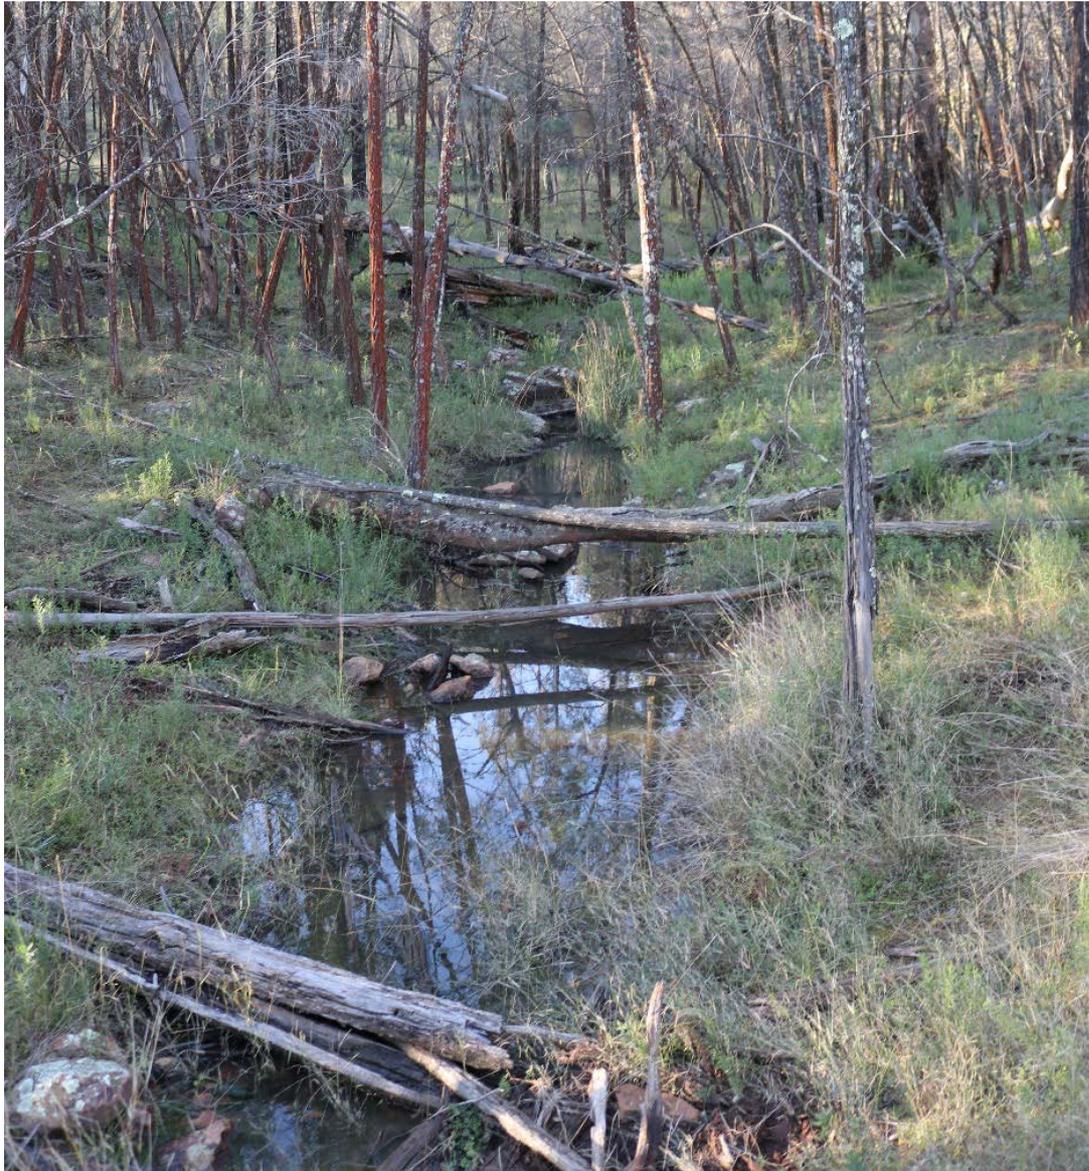
| A healthy drainage line on Dowd's hill. Photo taken 27 June 2021.

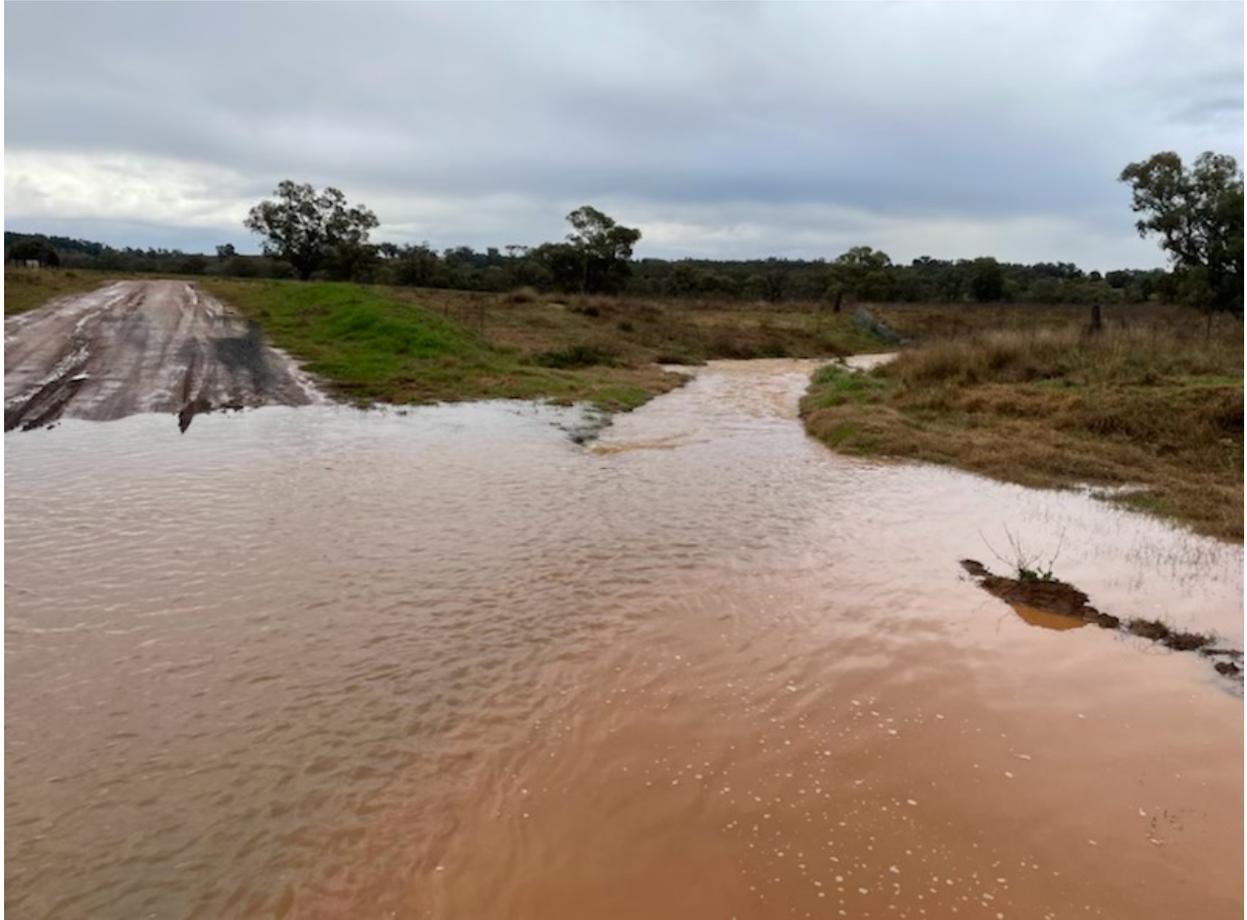
Watercourse B flowing across Toongi Road on “Toongi Valley” discharges in Wambangalang Creek. Despite very good ground cover surface water does contain suspended solids. Photo taken 7 July 2021.

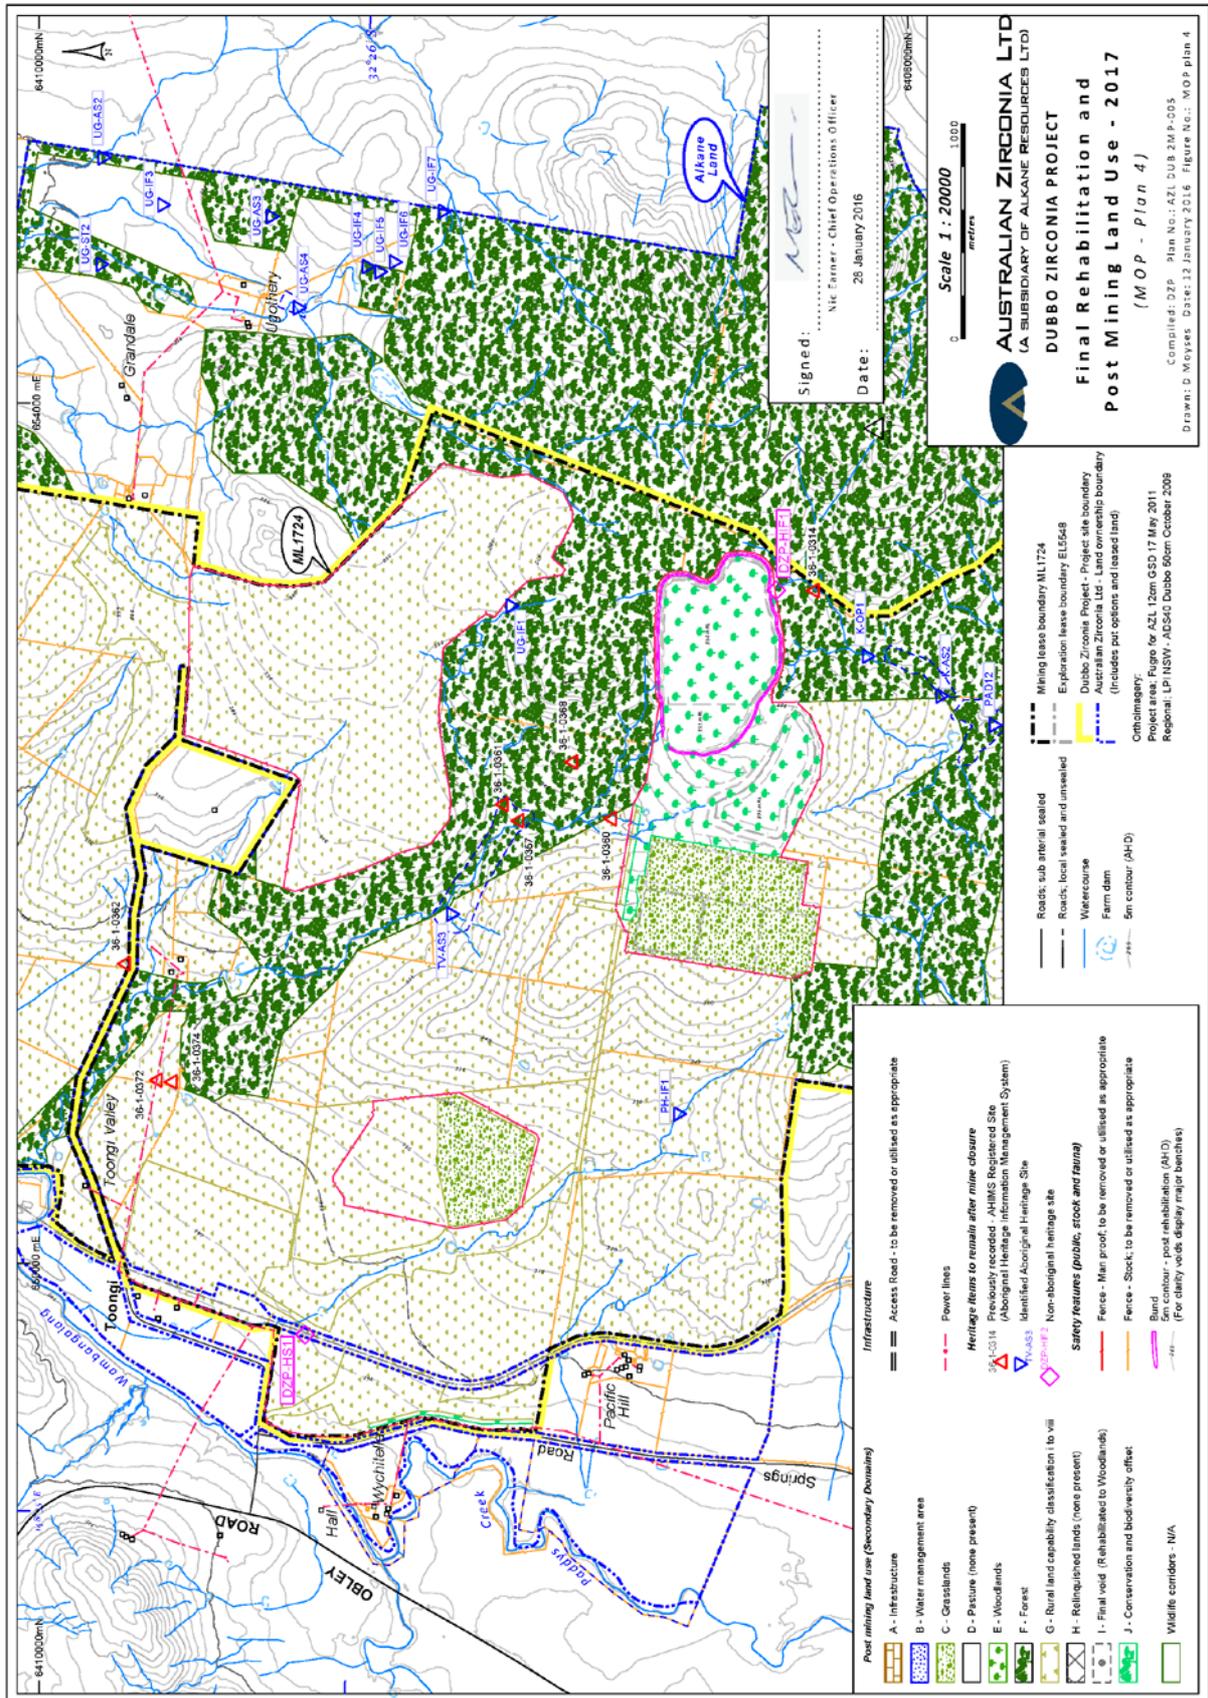
Figure 7: MOP Plan 4 showing proposed final land uses at DZP

Provide rehabilitated woodland communities which adjoin the established Biodiversity Offset Area to maximise the wildlife corridors created within the local setting.	Undertake habitat augmentation to improve and promote corridors for fauna movement linking adjacent remnant woodland vegetation with the rehabilitation of the Mine.	Establish woodland vegetation over the landform equivalent to local analogues of that community. Visual identification of wildlife corridors within the largely agricultural setting. Conserve under a Conservation PVP 1021ha of remnant native vegetation in accordance with a Biodiversity Offset Strategy.
	Integrate areas of biodiversity enhancement and conservation with agriculture.		Undertake agricultural activities on the Mine Site, including within the BOA in accordance with a PVP and BMP.
Other	Allow for the relinquishment of the Mining Lease and the return of the security lodged over the Mining Lease within a reasonable time after the end of the mine life.		50% within 5 years of final rehabilitation. 100% within 10 years of final rehabilitation.

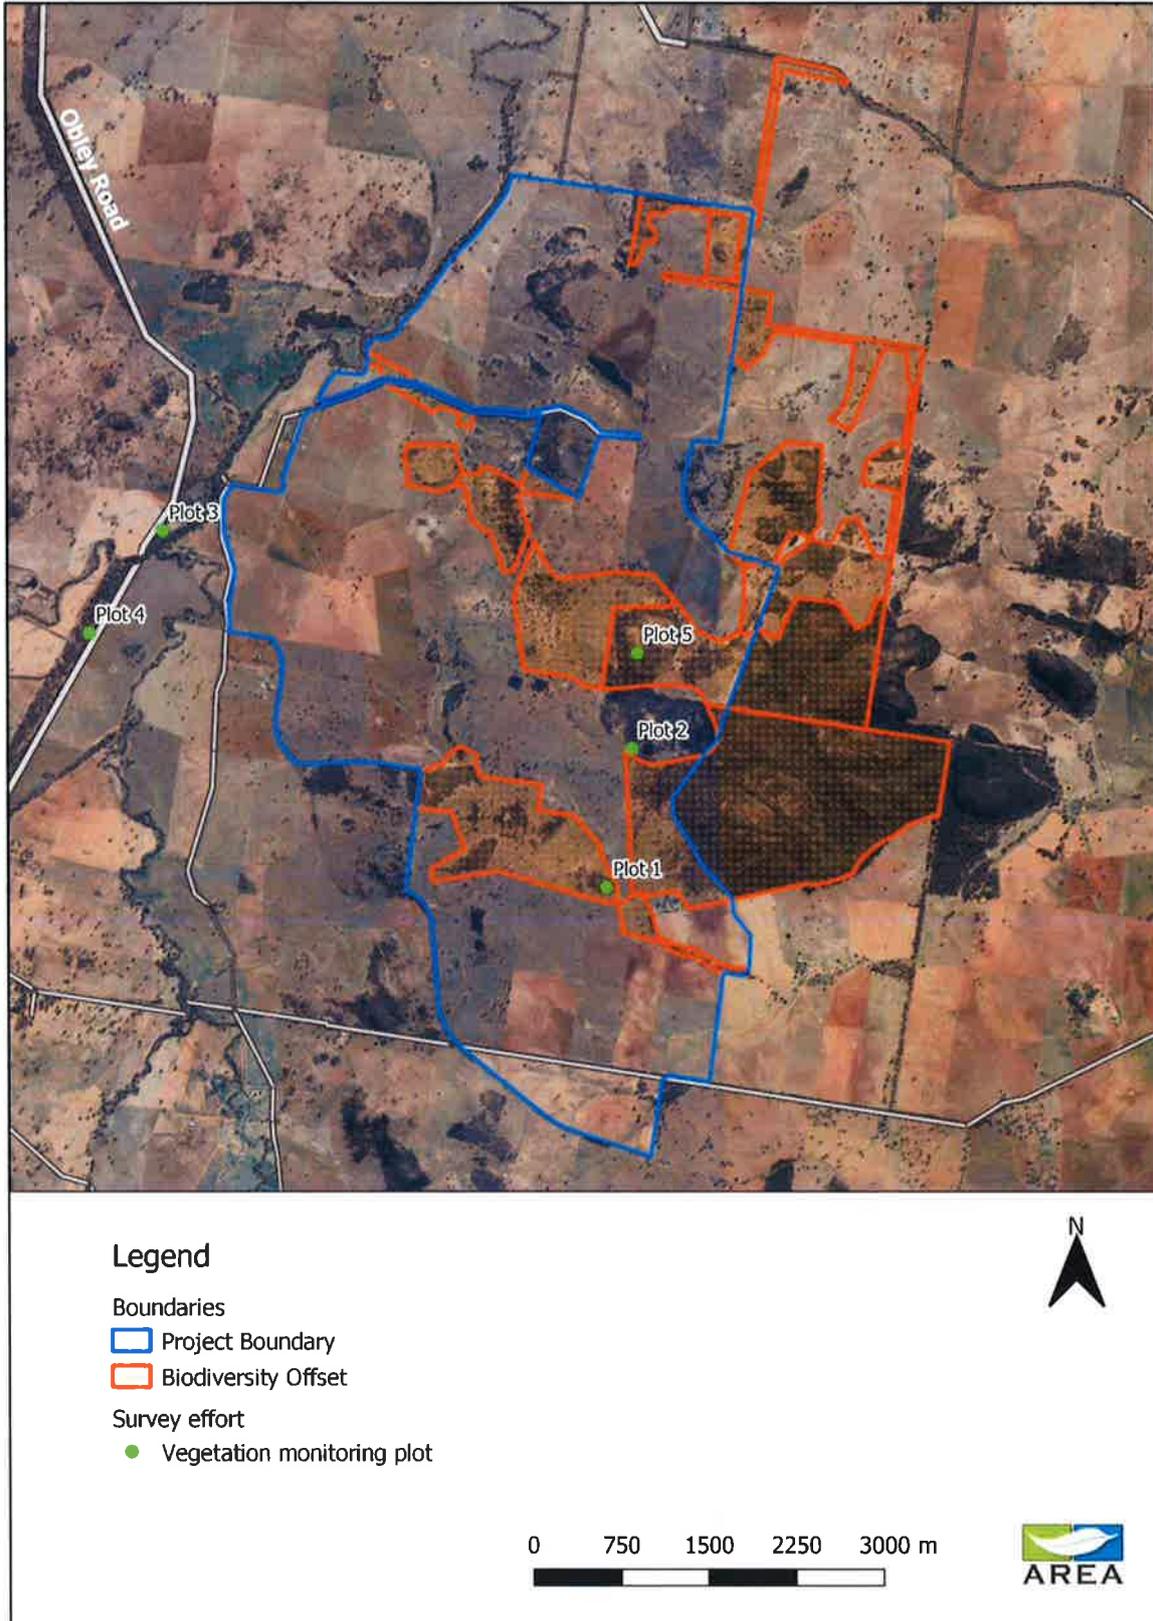
Figure 2-1: Vegetation plot location

Plot ID	Easting (GDA94 Zone 55)	Northing (GDA94 Zone 55)
1	652426	6405475
2	652663	6406659
3	648677	6408583
4	648032	6407720
5	652722	6407476

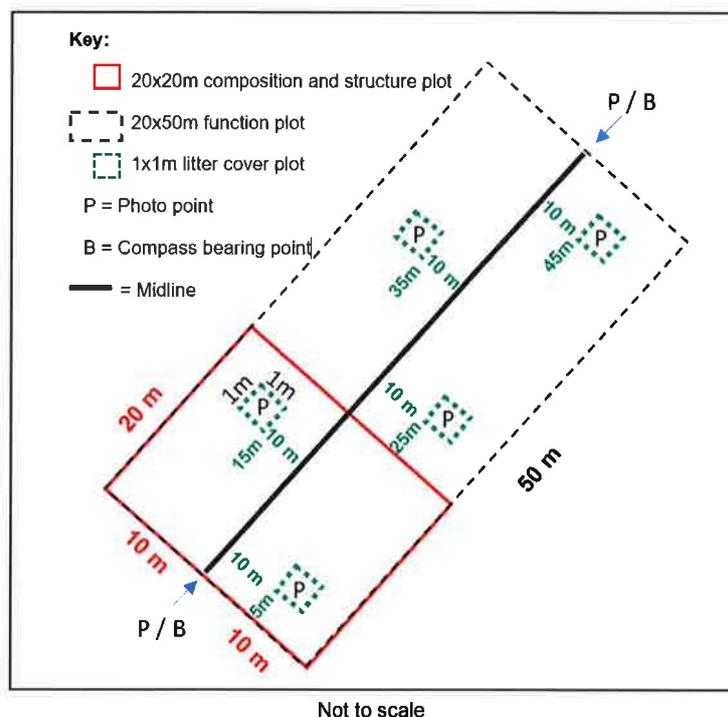
- Five 1m² sub-plots are used to assess average litter cover (and other optional groundcover components) for the plot.

Figure 2-2: Nested plot layout (20x20m = composition and structure plot, 20x50m = function attribute assessment plot, 1x1m = litter cover plot)
