Australian Strategic Materials (Holdings) Ltd ABN 51 091 489 511

Annual Review & Annual Rehabilitation Report

1 July 2022 – 30 June 2023

Australian Strategic Materials, Dubbo Project

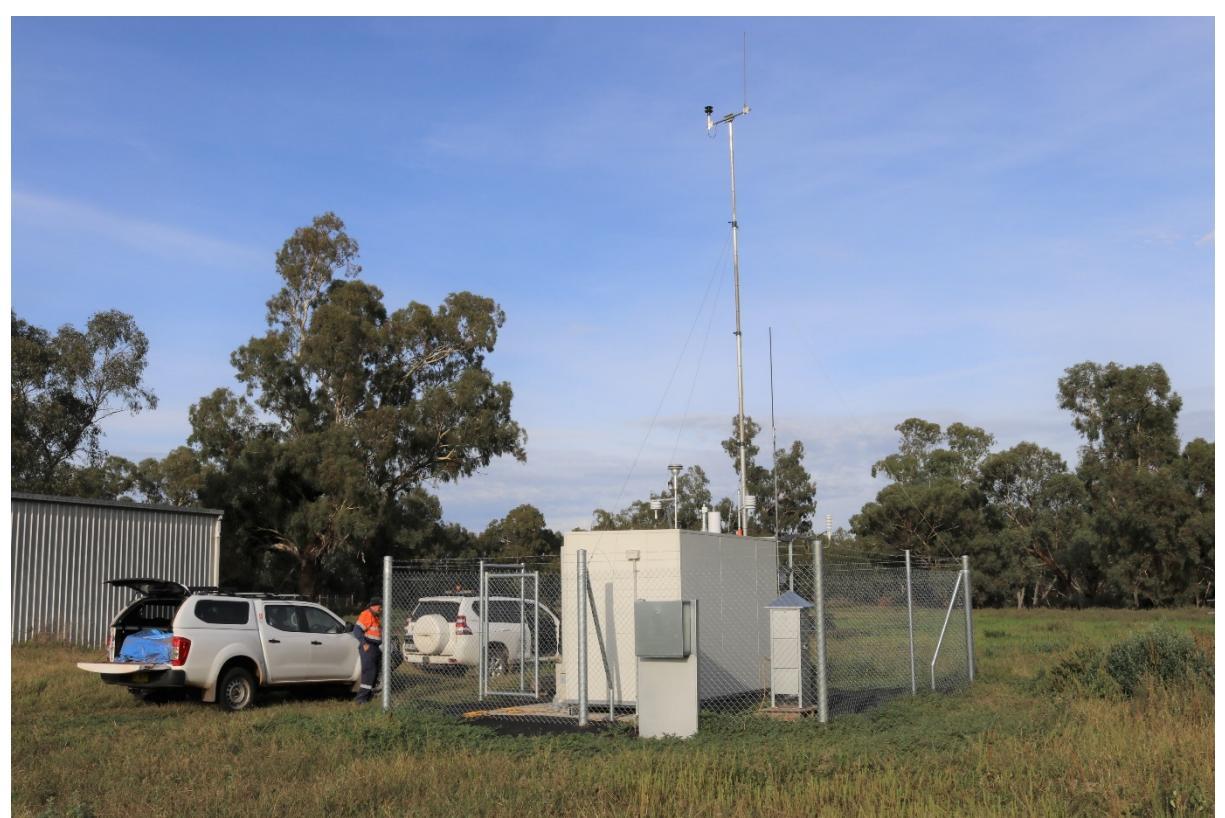
An environmental monitoring shelter supplied by ACOEM was installed during the previous reporting period southeast of the nearest sensitive receptor (Toongi Hall).

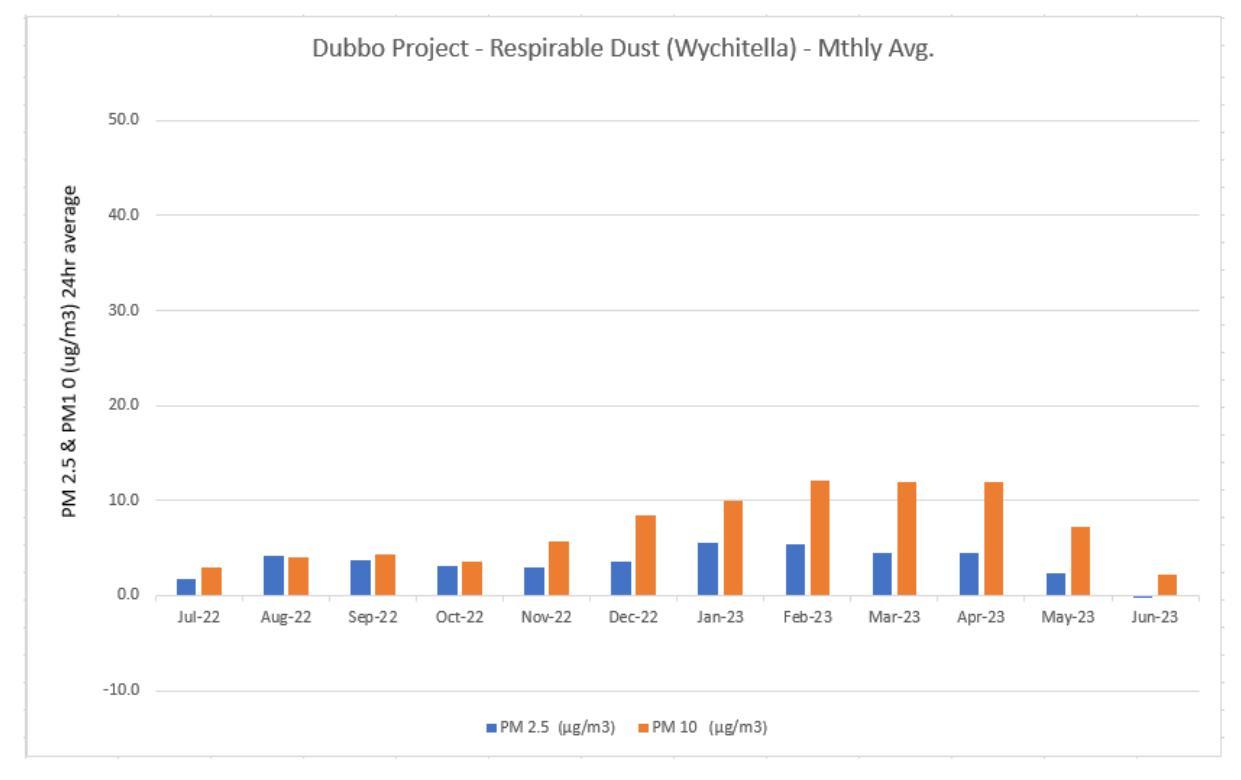
Figure 7: PM 2.5 & 10 monthly averages at Wychitella monitoring shelter

PM10 (suspended particulates <10 microns in size) were monitored continuously once the monitoring shelter at Wychitella was commissioned. Data is processed by ACOEM and monthly report provided to ASM. The abnormally wet first six months of the monitoring period has seen very low concentrations of $PM_{10 and} PM_{2.5}$ in the air.

Minimal dust management measures were employed during this reporting period as project construction has not commenced. These are baseline monitoring results which are influenced by seasonal and routine agricultural practices.

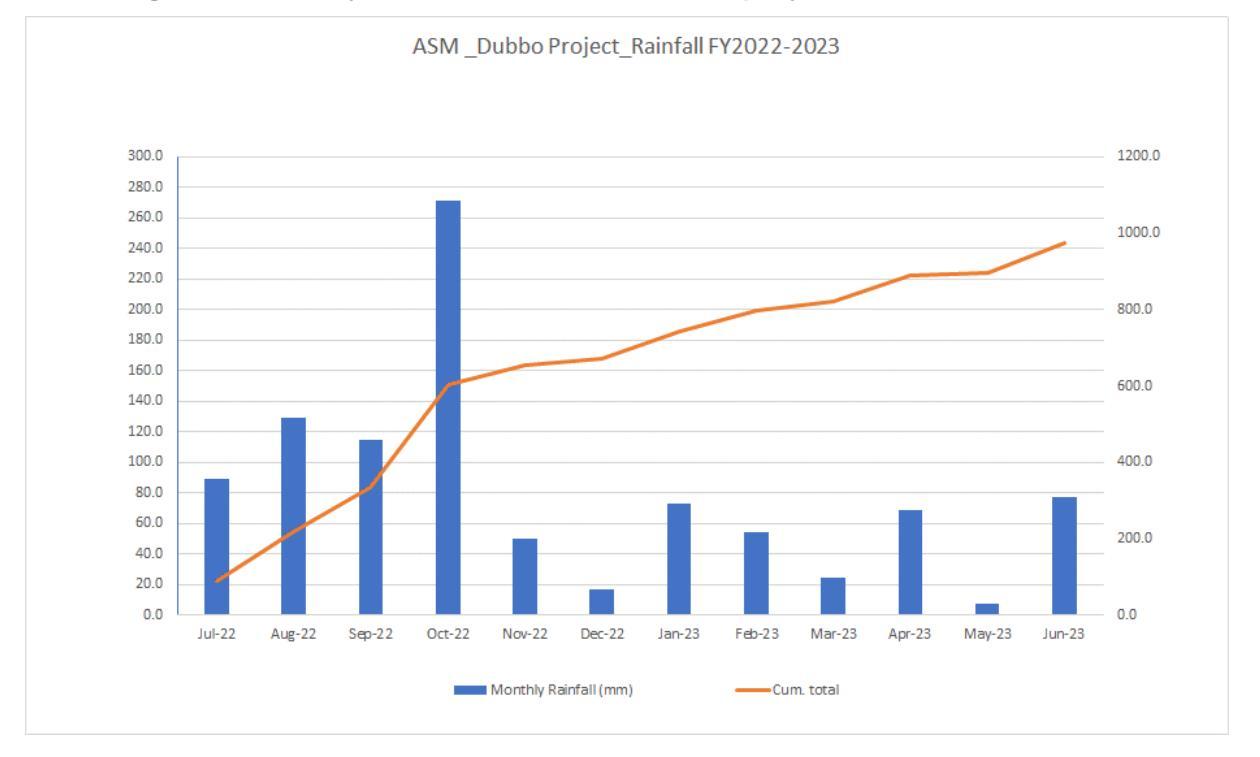
Figure 8: Monthly and cumulative rainfall on project site to 30 June 2023.

A total 974.8mm of rain fell over 96 days in the reporting period (880.6mm over 103 days in the previous 12 months) which concludes an unprecedented 36 months of well above average rainfall. These wet seasons follwed a short but severe drought of well below average rainfall years in 2018-2019. The second half of the reporting period was well below average rainfall which has led to district conditions where handfeeding livestock is widespread as at 30 June 2023.

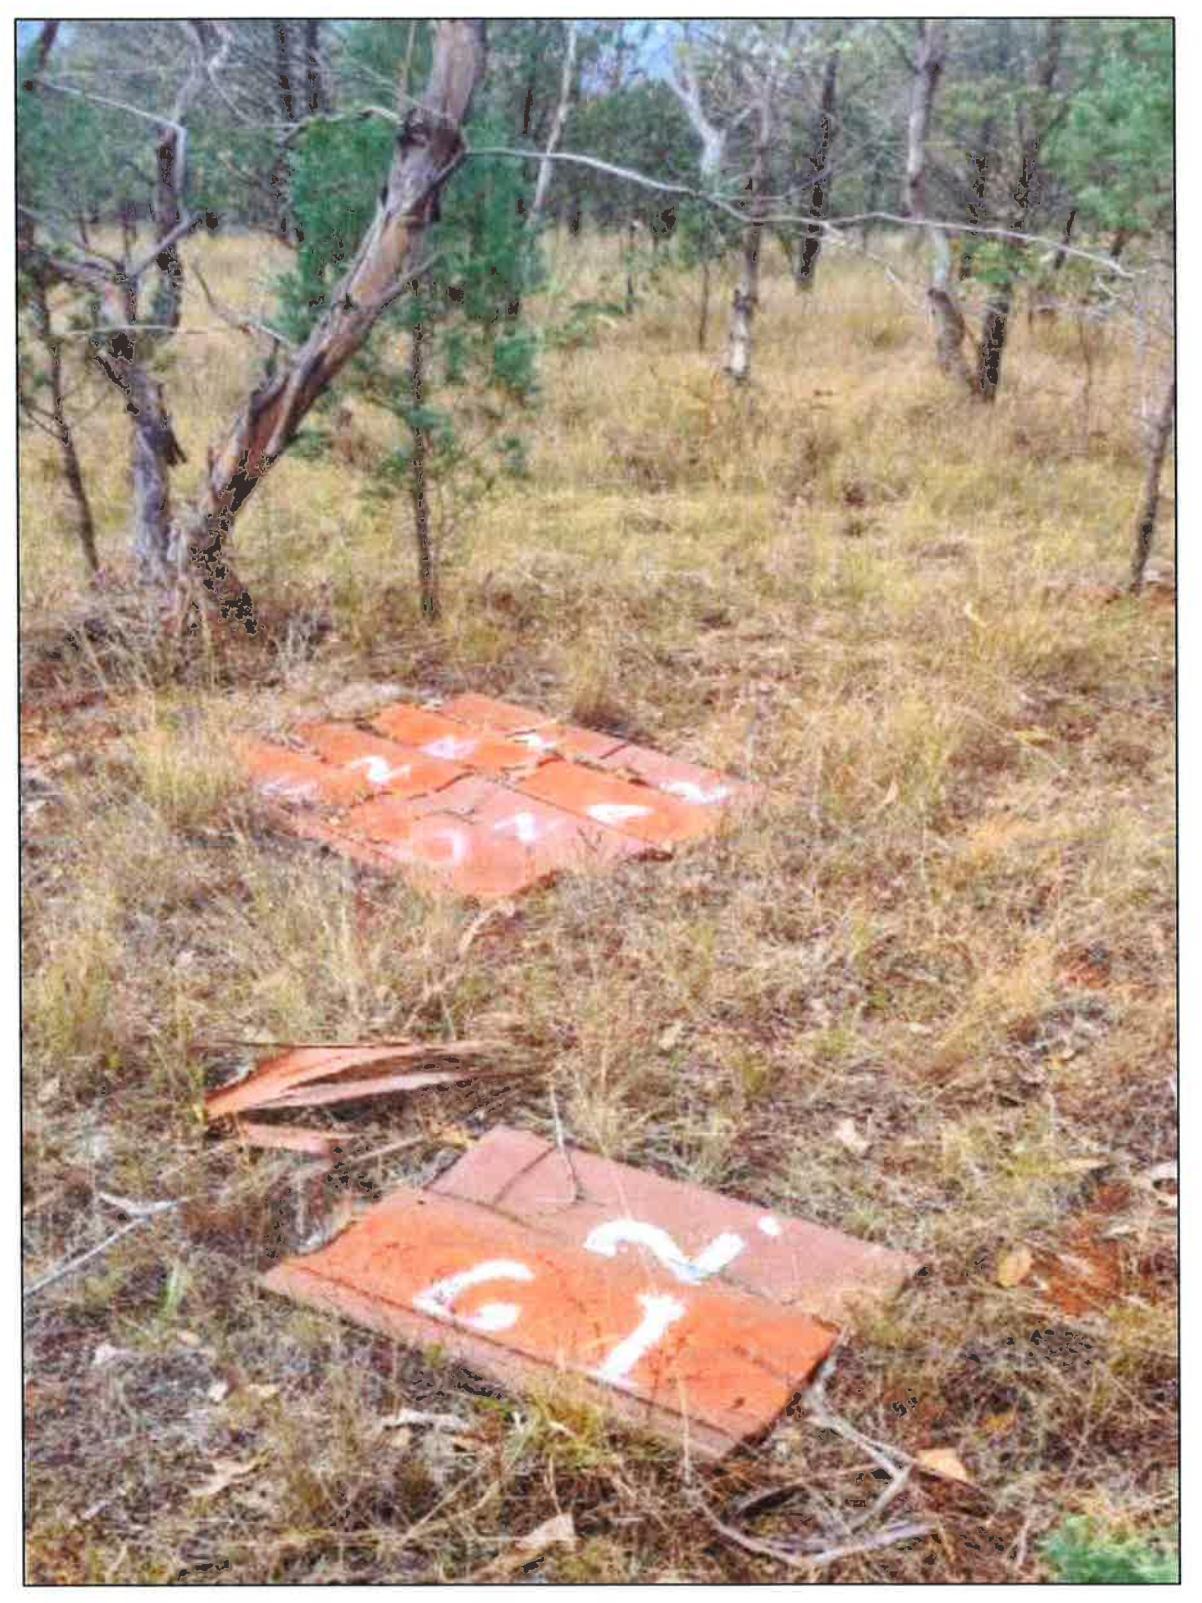
Plate 2-1: Tile set configuration

To ensure the survey took place under optimal conditions, the monitoring program was carried out days suitable for their detection. This monitoring program evaluated artificial tile habitats established in 2013. These locations encompass a total of 50 roof tiles distributed across 10 distinct sets. Each set comprises a cluster of four tiles, juxtaposed with a lone tile. This arrangement is designed to discern whether a group of tiles offers a higher likelihood of serving as PTWL habitat compared to individual tiles. The specific configuration of this set-up is illustrated in Plate 2.1.

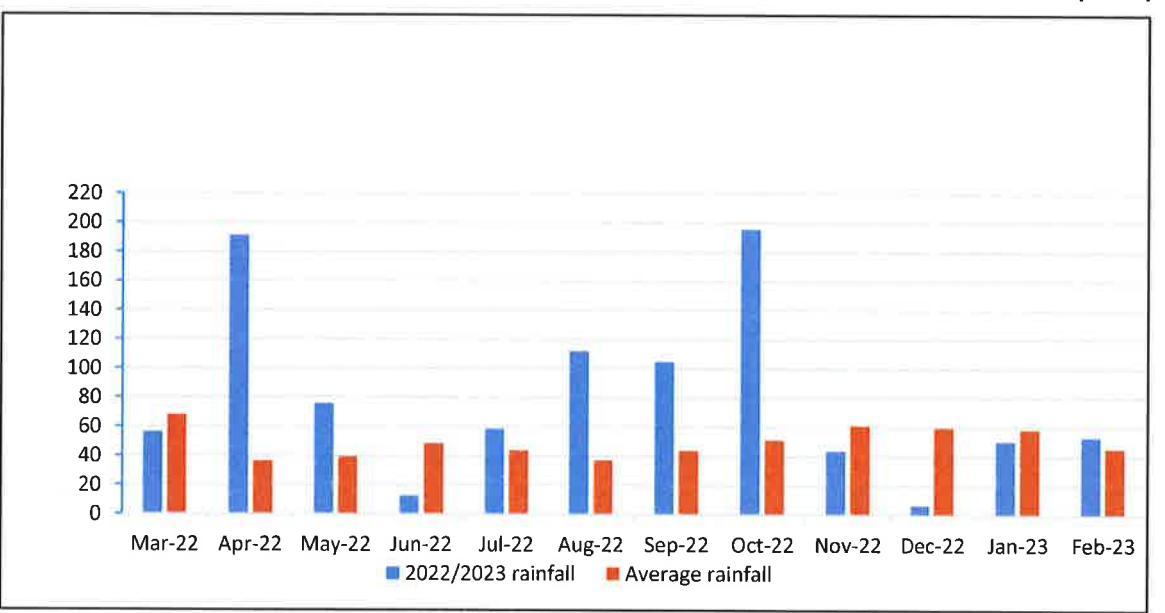
Figure 3-1: Dubbo Regional Airport rainfall averages and 2022/23 rainfall totals (BoM)

February's rainfall fell slightly below the average with a total of 45.3 millimetres, while January surpassed the average with 58.4 millimetres. Figure 3.1 illustrates the cumulative rainfall leading up to the monitoring event, comparing these values to the monthly averages.

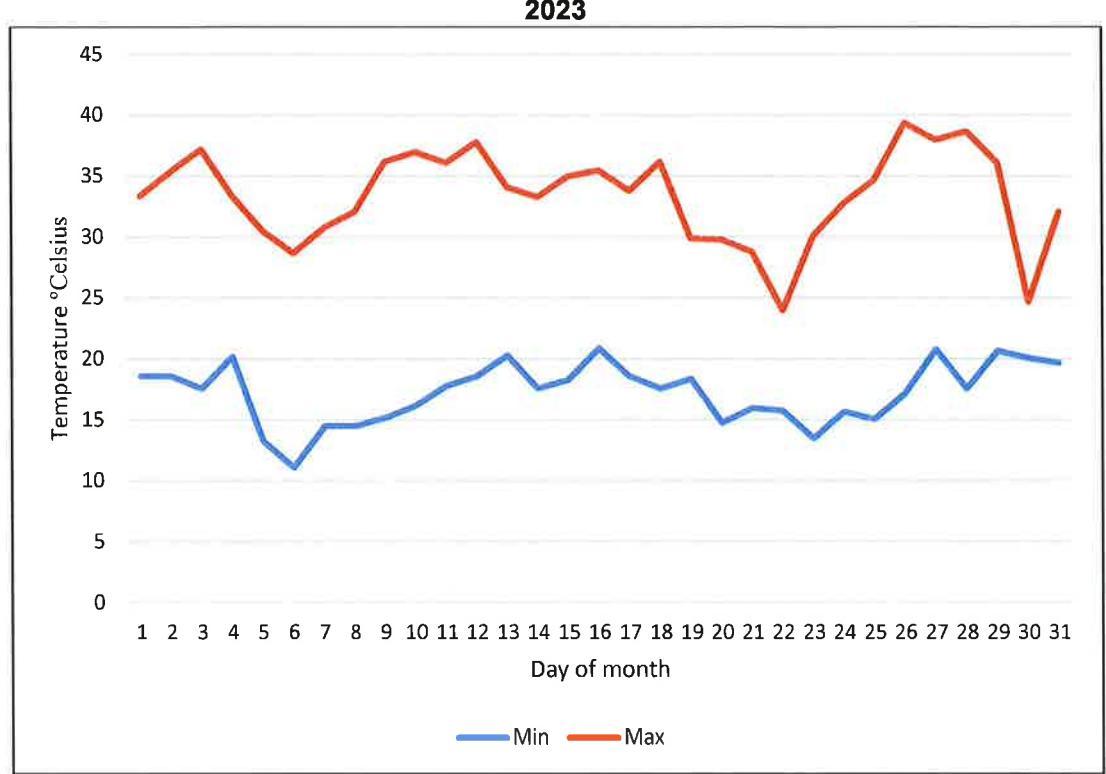
Figure 3-2: Dubbo Regional Airport maximum and minimum temperatures for January 2023

Figure 3-2 depicts the minimum and maximum temperatures for January 2023.

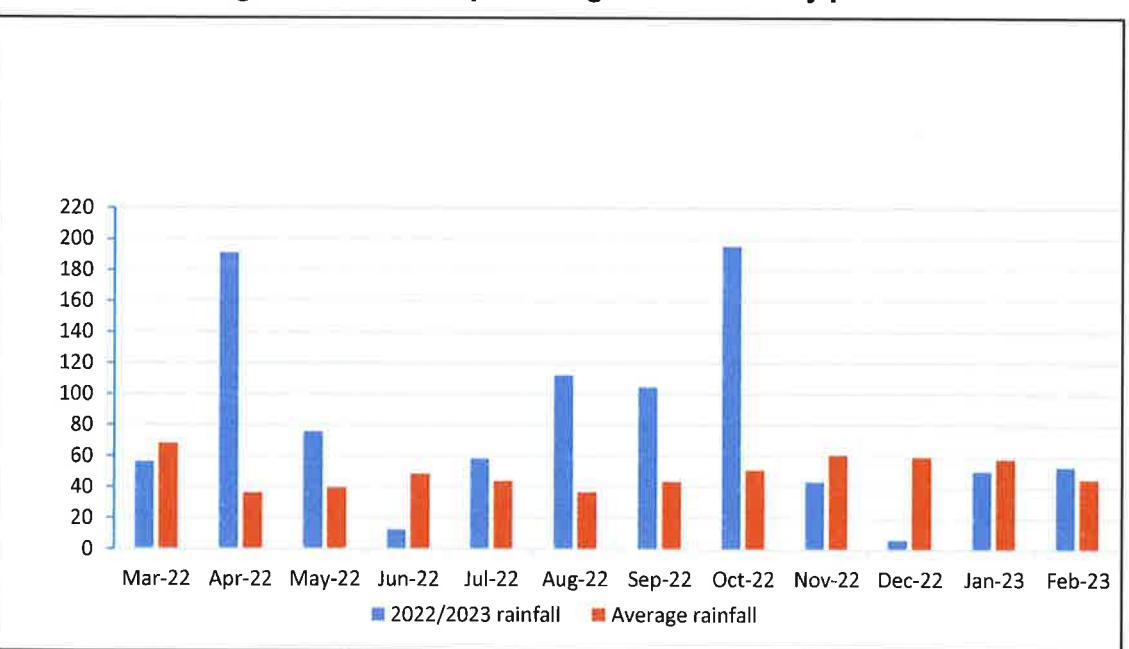
Figure 4-2: Rainfall preceding the 2023 survey period

Although the month of January 2023 experienced below-average rainfall, it's worth mentioning that the subsequent 2022 monitoring event contributed to an increased average rainfall due to notable precipitation periods throughout the year, as depicted in Figure 4.2.

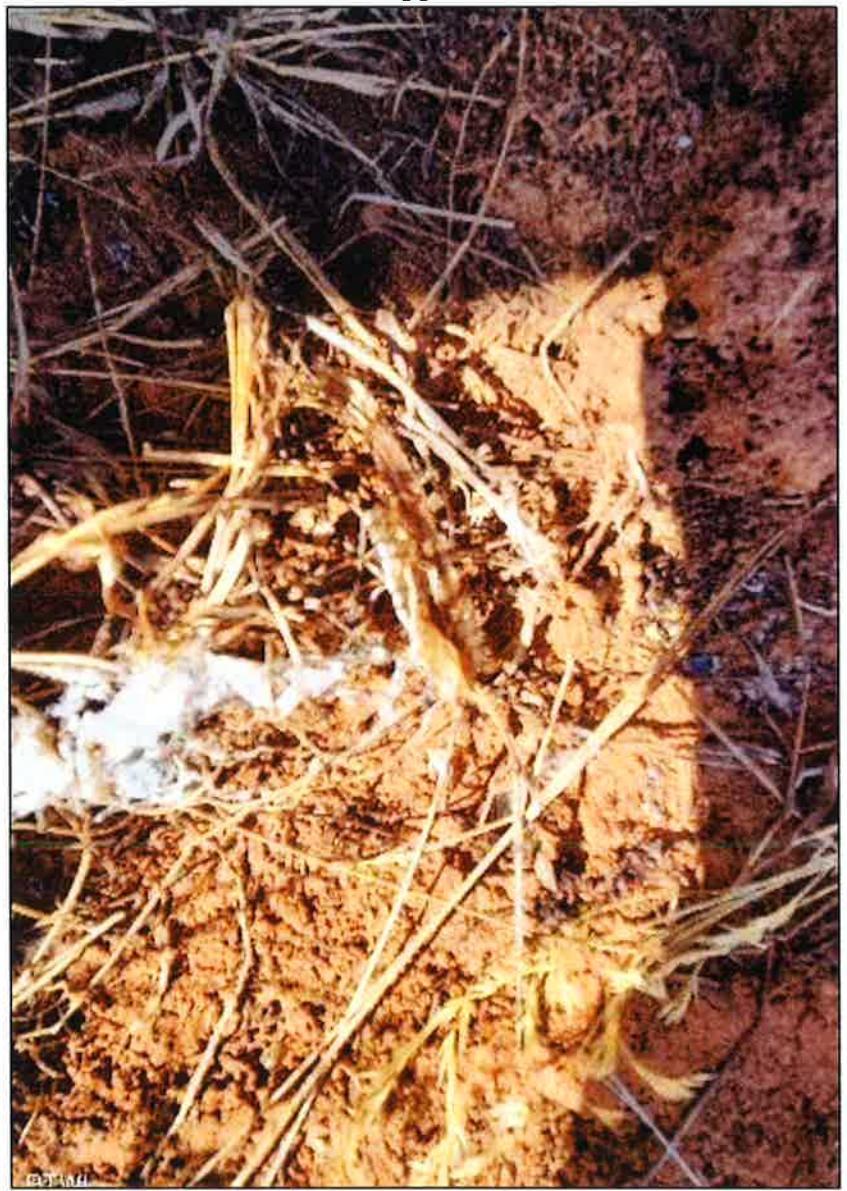
Plate 6-1: Ant burrows, ant eggs underneath artificial habitat

The large per cent of occurrence of ants under tiles is an indication of food being readily available for the PTWL. Plate 6-1displays ant burrows, ant eggs and spider web under a surveyed tile.

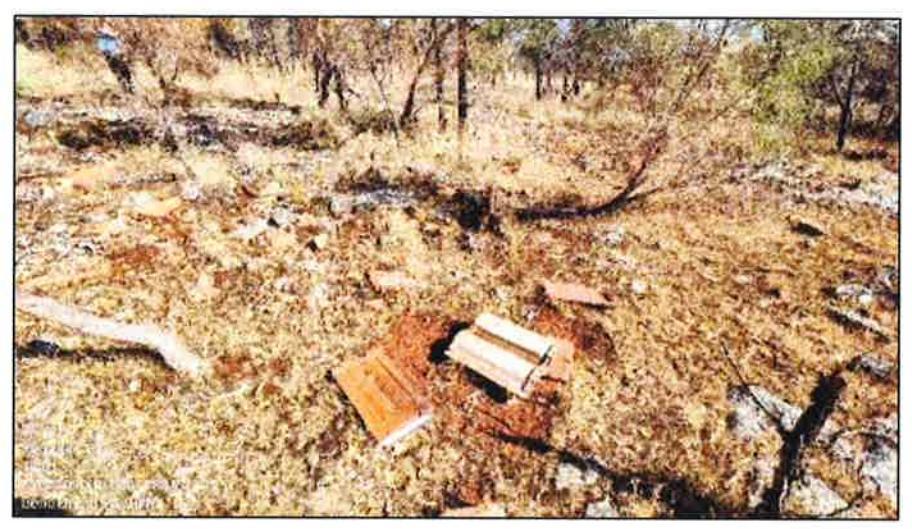
Plate 6-2: Tiles disturbed by pigs

Other reptiles or evidence of habitation were found under 13 per cent of tile sets. This is an increase from seven per cent in 2022 to nine per cent in 2020. However, nine per cent is a decrease from 18 per cent in 2018. Pig disturbance could have attributed to the low reptile count (Plate 6-2).

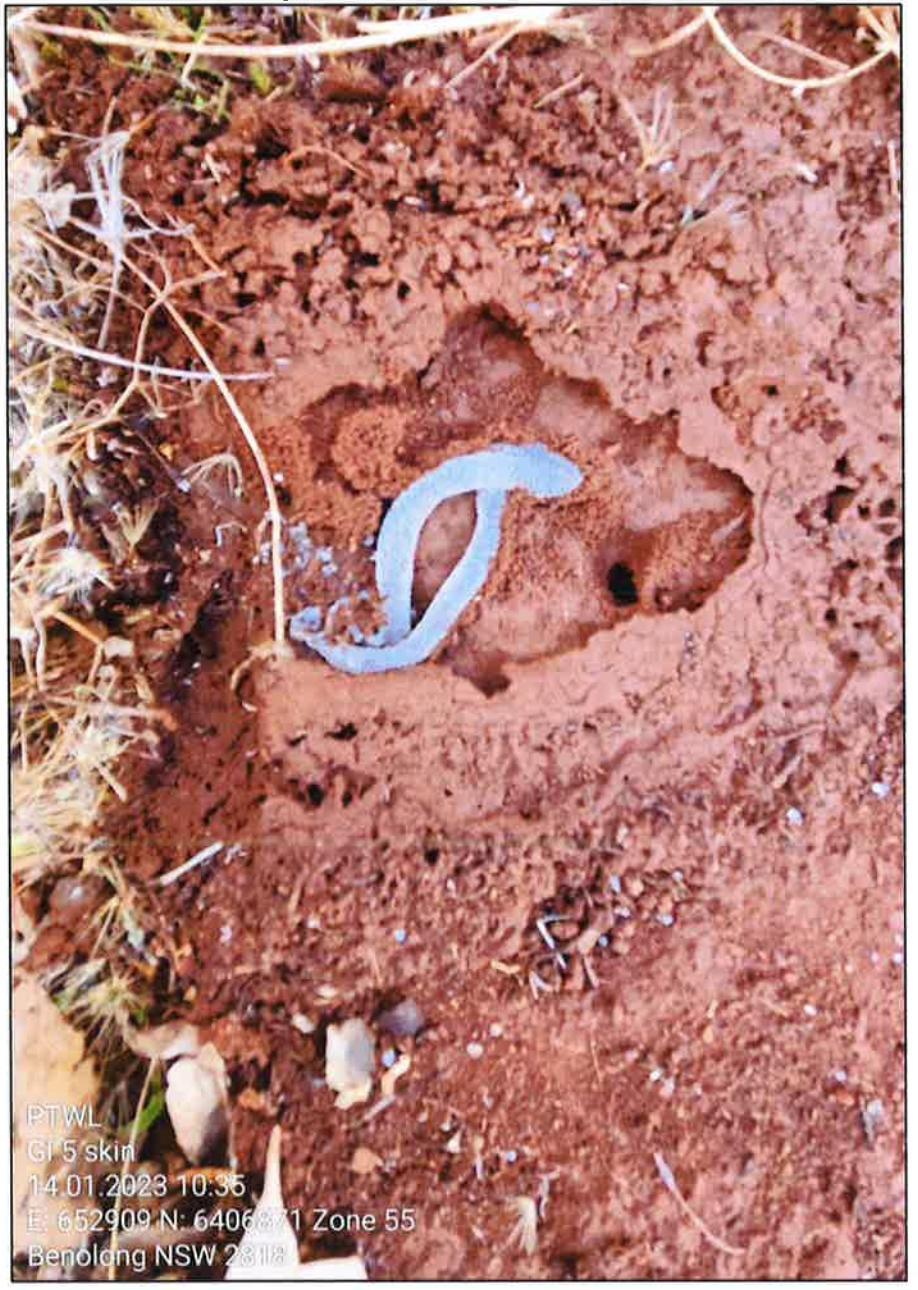
Plate 7-1: Likely PTWL skin underneath artificial habitat

One likely PTWL skin was observed on January 14 2023 at the Glen Idol monitoring location GDA94/MGA Zone 55 652909E 6406871N under tile set 5ABCD where soil temperature was 24.4 °Celsius (Plate 7-1) (Figure 7-1).
